# Case Study

## LOMA'S X-RAY UNIT TAKES QUALITY TO A NEW LEVEL FOR CANADIAN DESSERT MANUFACTURER

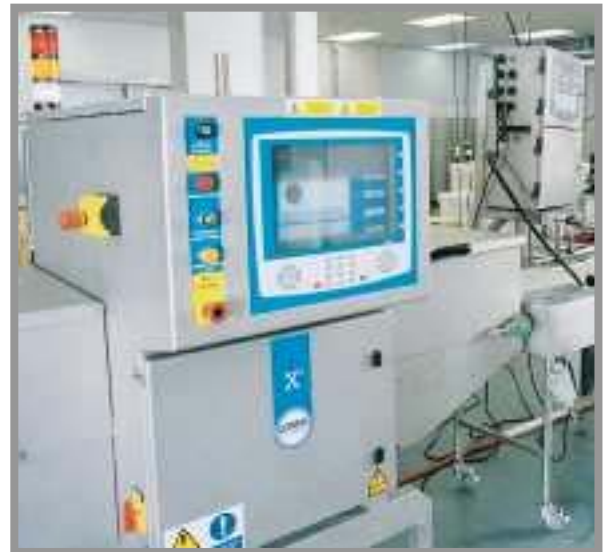
"We started by selecting three different X-ray equipment manufacturers. It was important for us to examine the equipment, review the specifications and make a decision based on performance," Martin says. After a stringent review process, Martin Dessert settled on Loma System's X<sup>3</sup> conveyor model, X-ray inspection system. The unit can detect a wide variety of contaminants (such as gravel, glass, stones) that metal detectors cannot, as well as easily and accurately find small pieces of metal within a metallic or aluminum trays.

Further, the unit features a large monitor with a live X-ray image, which displays detected contaminants in color. Also standard are QA reports, batch reports, fault reports, rejected image capture facility and optional communication connections.

Additionally, the unit features Intralox conveyor belting. Because Intralox belts have varying degrees of density, some competitive units cannot be calibrated properly to adjust for the variances. Loma's software has been programmed to cope with the variances and not lose sensitivity.
